INDOOR AIR QUALITY ASSESSMENT

**Malden Fire Department, Maplewood Station
665 Salem Street
Malden, Massachusetts 02148**

Prepared by:
Massachusetts Department of Public Health
Center for Environmental Health
Emergency Response/Indoor Air Quality Program
January 2006

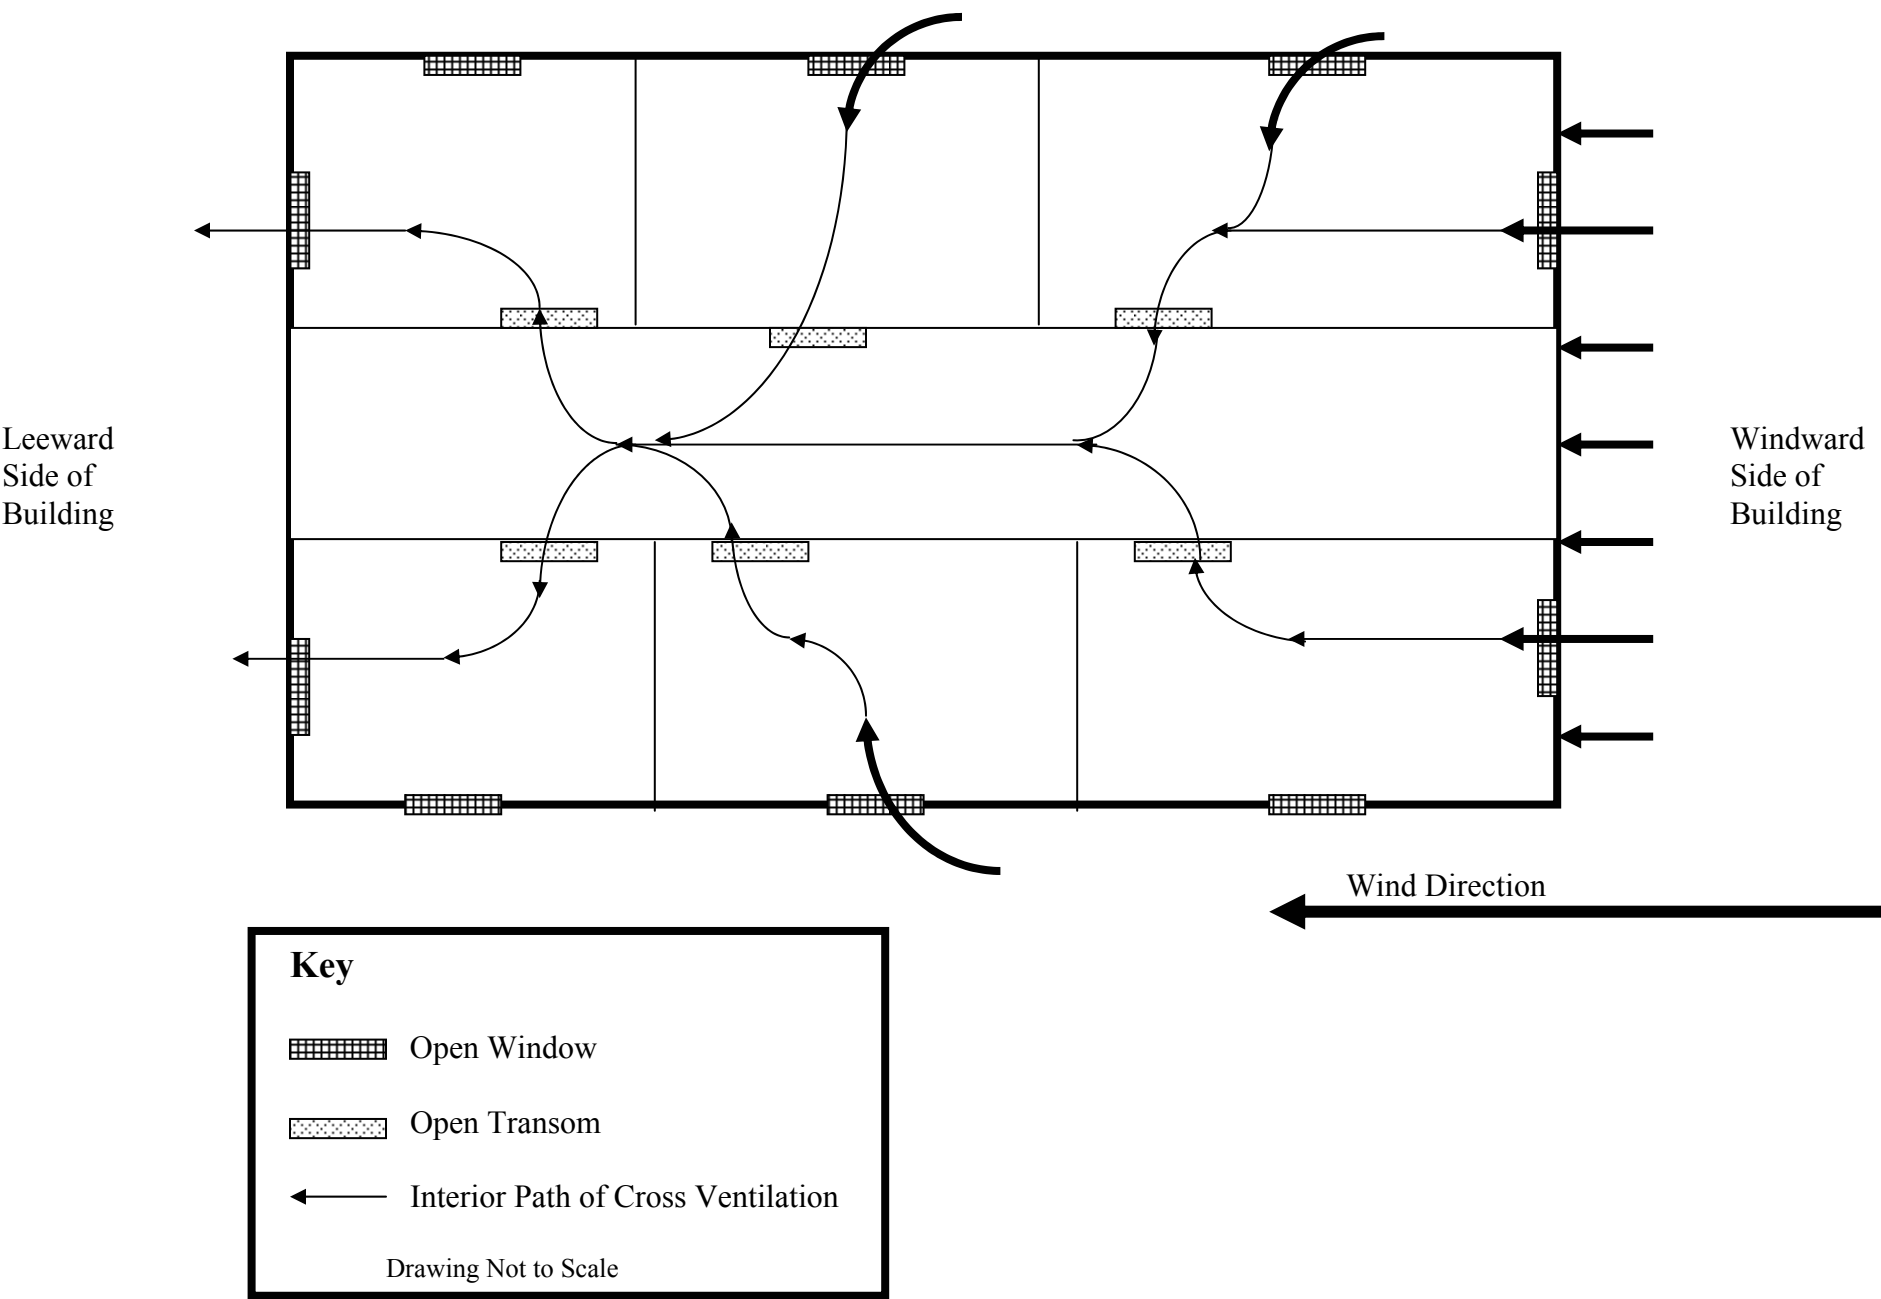
Figure 1

The station was originally configured in a manner to use cross-ventilation to provide comfort for building occupants. The building is equipped with windows on opposing exterior walls. In addition, the building has hinged windows located above the hallway doors. These hinged windows (called transoms, Pictures 1 and 2) enable building occupants to close the hallway doors while maintaining a pathway for airflow. This design allows for airflow to enter an open window, pass through an office and subsequently pass through the open transom. Airflow then enters the hallway, passing through the opposing open office transom, into the opposing room and finally exits the building on the leeward side (opposite the windward side) (Figure 1). With all windows and transoms open, airflow can be maintained in a building regardless of the direction of the wind. The system fails if the windows or transoms are closed (Figure 2). In this case, the use of transoms has been nullified by the sealing of internal windows, preventing airflow (Picture 3).

Cross Ventilation in a Building Using Open Windows and Transoms

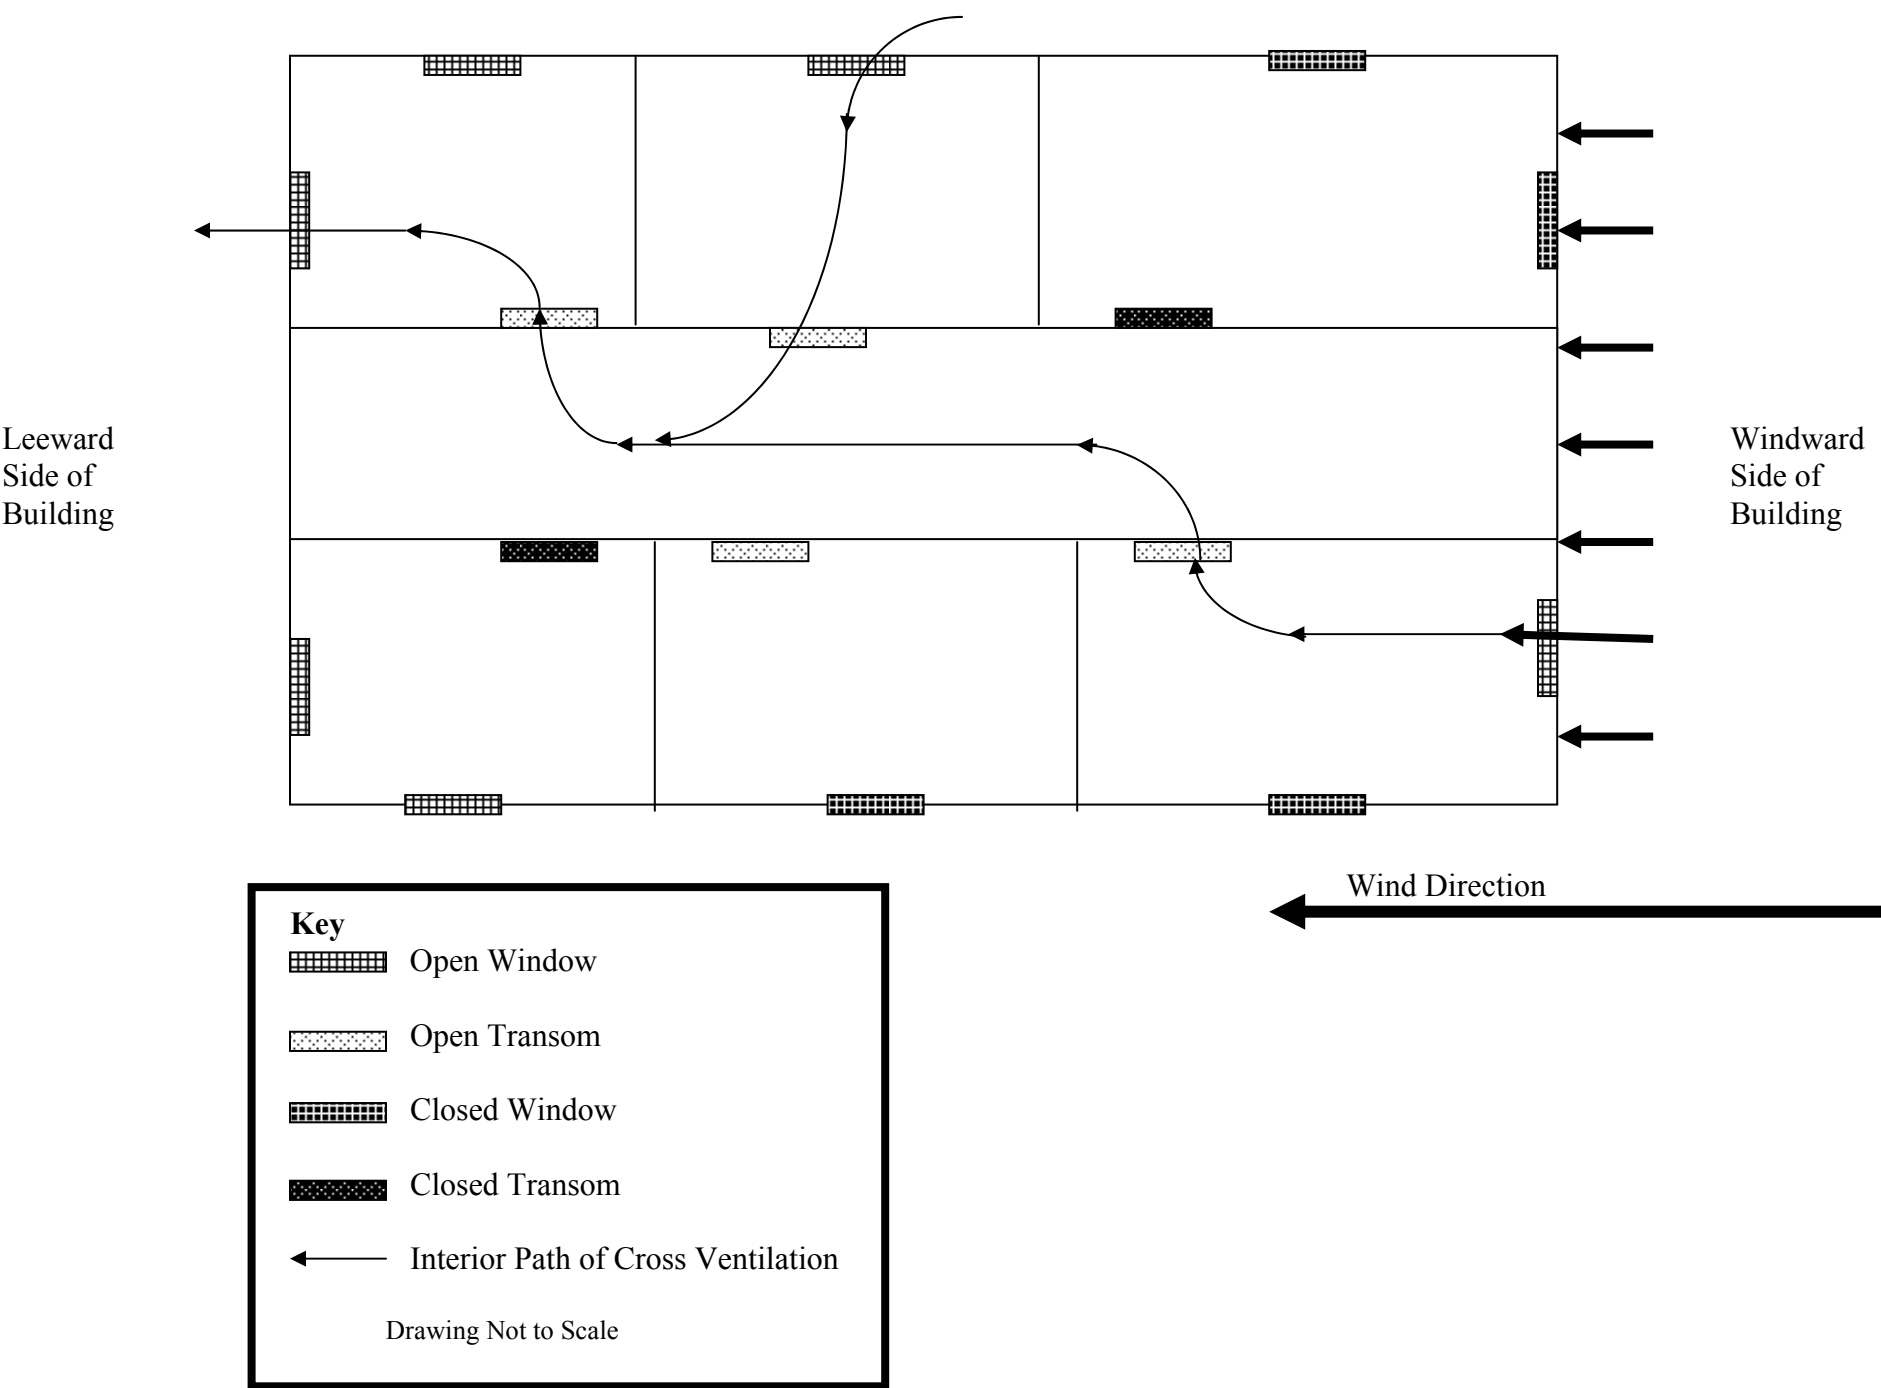
Figure 2

Inhibition of Cross Ventilation in a Building with Several Windows and Transoms Closed
